4. Landscape Appraisal

Bury Metropolitan Borough Council
St Mary's Conservation Area
 Map 3. Landscape Character Areas
 Scale: 1:3,000 @ A3
 Date: 10/1/06
 Drawing: 03
 Project: 03
 Revision: 1
 Drawing No: 03/06/03
 Project No: 03/06/03

Project: **St Mary's Conservation Area**

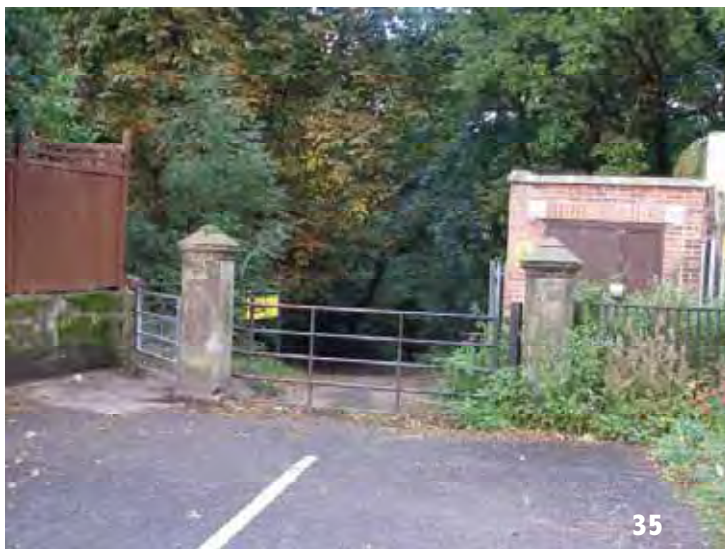
- 4.2.25 The entrance to the Clough from this part of the Conservation Area however, is not auspicious, as photo 35 demonstrates. As previously described, a collection of different gate and fence details, poor signage, a small electricity substation, indistinct and poor path surfacing and an absence of vegetation management, leads to an uninviting entrance.

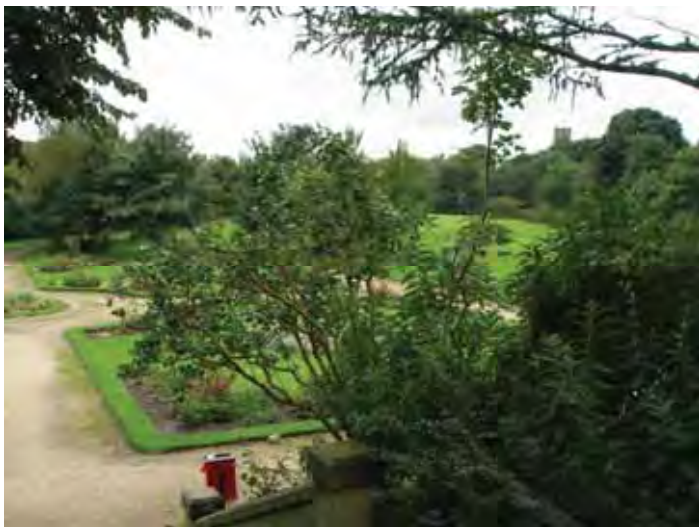
36: View of Flower Garden from top of main steps

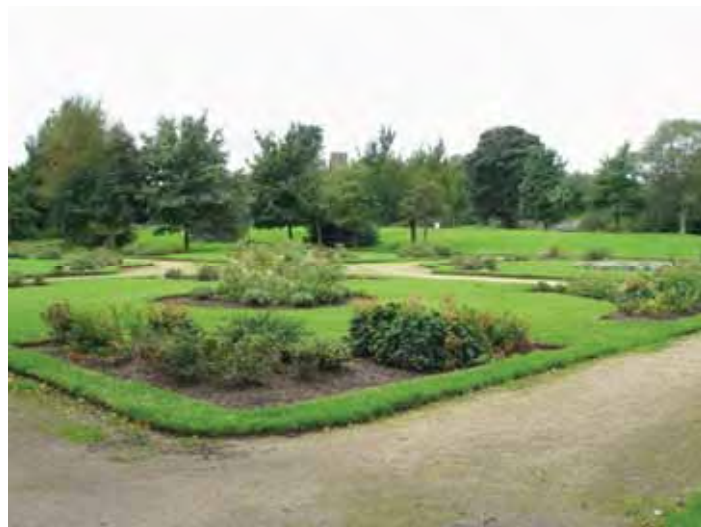
former bandstand site. The shape of the beds within the grass quarters are not original and are now filled with low growing shrubs such as photinia, berberis, hebe, and ornamental grasses (**photo 37**). A recent bird bath feature has been placed in the central circular bed. The grass surface is well maintained but the surrounding bound gravel paths are in poor condition.

37: Flower beds now planted with low shrubs

f) St Mary's Park Allowing for difficulties with current revenue budget costs seek to restore the flower garden to its 1930s design incorporating improvements to paths and flower beds. Improve both physical and visual connections with the Clough by restoring paths, steps etc and thinning trees and understorey of the Clough. Widen and re-surface the main path link from flower garden to the entrance to the Clough.

The present garden does not read well and has substantial gaps in the planting cover. The paths are also in need of restoration with better defined edges. The plant mix is based on shrub rather than herbaceous perennials and lacks colour and interest as a result. Substituting a more diverse and colour orientated planting pattern perhaps with more emphasis on bedding plants at key points would transform the attractiveness and appeal of this garden. It would also become more maintenance intensive. We also recommend some low level enclosure on the open north and west sides to improve its definition. More seating should be provided throughout. Also the links to the Clough could be improved such as restoring the path connecting the Flower Garden area to the sides of the Clough and the main bridging point.

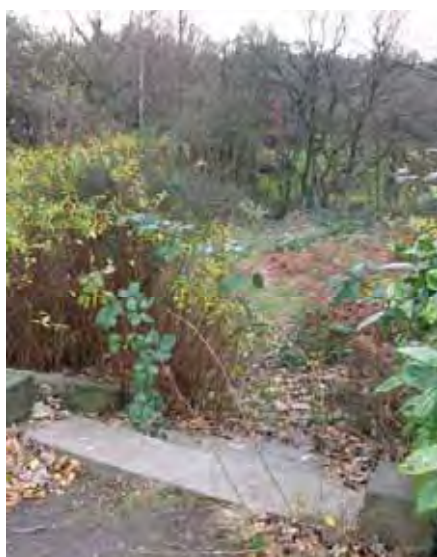
38: Steps from Park down to the Clough now largely hidden

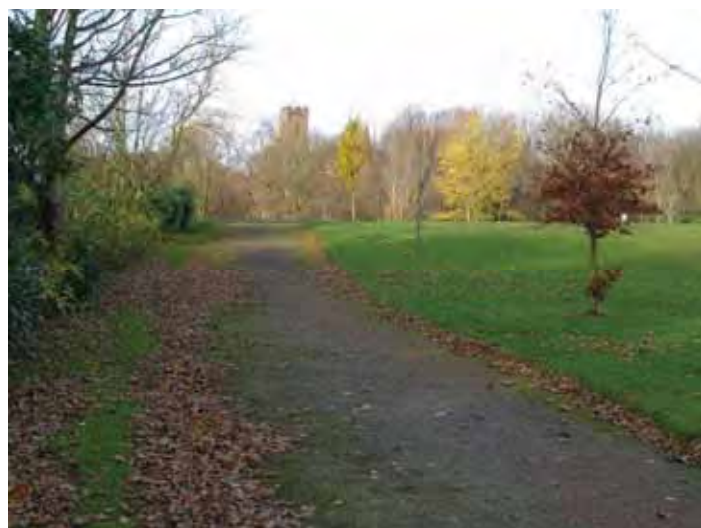
- 4.2.12 The character of the 'avenue' approach to the former bandstand site has also changed in recent years. The elms have been replaced with a mix of tree standards including hornbeam, beech and sycamore and the former red shale surface of the bound gravel drive has since been superseded by the current path material (**photo 39**).

39: Approach to bandstand site with new tree planting

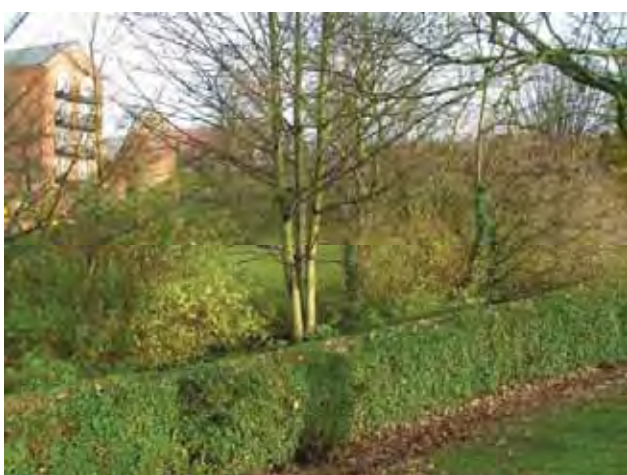
- 4.2.14 Finally, the former Centenary Garden area is now separated from the main area of St Mary's Park by a privet hedge supplemented with shrubs and small trees (**photo 40**). This area is now given over to grass and is poorly drained. Some ornamental trees have been planted, including fastigiate hornbeam, and along the top of the bank, adjacent to the road, a variety of street trees (8No.) have recently been planted including birch and hornbeam. The path leading down from Bury New Road consists of stone steps and cobbles for the first part but then reverts to a bound gravel surface that suffers from poor drainage, necessitating the introduction of a timber boardwalk (**photo 41**). The path corridor is narrow and confined as it follows the side of the Conservative Club bowling green. As an ancient trackway from the former Rectory to the Church it remains historically important.

40: Former centenary garden screened by hedge and trees

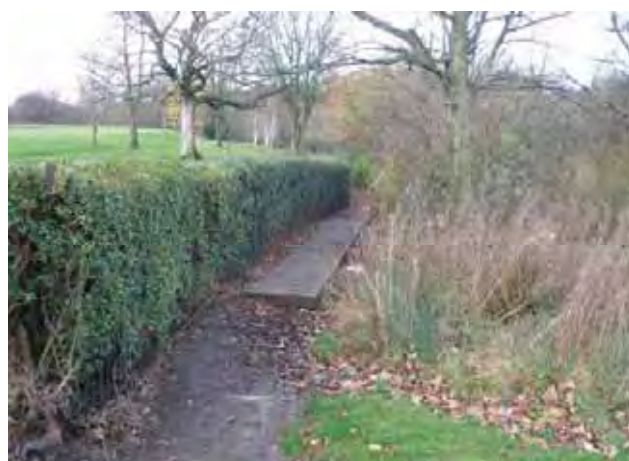
41: Path leading down from Bury New Road is in poor condition

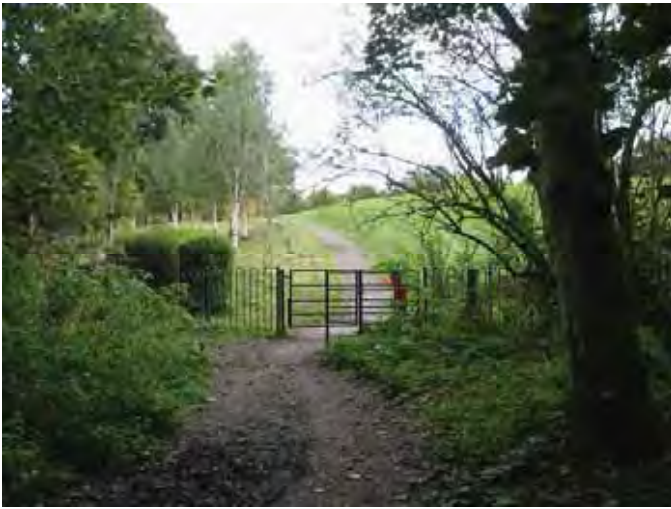
42: The path leading to the Park is in poor condition

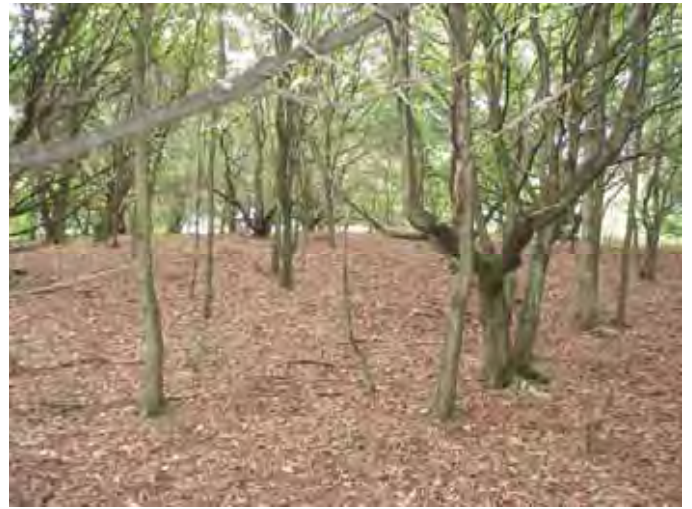
- 4.2.17 Church Bank itself is now totally covered with dense oak scrub with no discernible understorey (**photo 43**). This was an open grassy bank as recently as the 1980s. The main path running along the foot of Church Bank is formed of unconsolidated bound gravel and is fairly narrow. It is edged by narrow strips of rough grass but for most of its length it is very enclosed by regenerating trees and scrub (**photo 44**). Further down this path, willows (either planted or colonising?) have recently in-filled an open grassy area which gave visual access to the stream (**photo 45**) and nearby there is an unsightly service building marked with graffiti (**photo 46**).

43: Dense scrub on Church Bank

e) Church Bank Clear most of the oak scrub on this bank to improve views to and from St Mary's church. Retain several groups or individual oaks but restore the bank to wildflower meadow. In particular handle the clearance sensitively with respect to opening up views of more modern development across the valley.

Historic analysis has shown that the oak trees on this bank have grown up as a result of natural regeneration as this area was previously a meadow. The oak trees are circa 30 years old. Removing almost all of them would allow views out over the clough and also improve views of the Church from the clough path and also St Mary's Park. The retention of a few individual clumps or individual trees would help to reduce the impact of the clearance and the creation of a wildflower meadow would help to improve ecological and visual diversity.

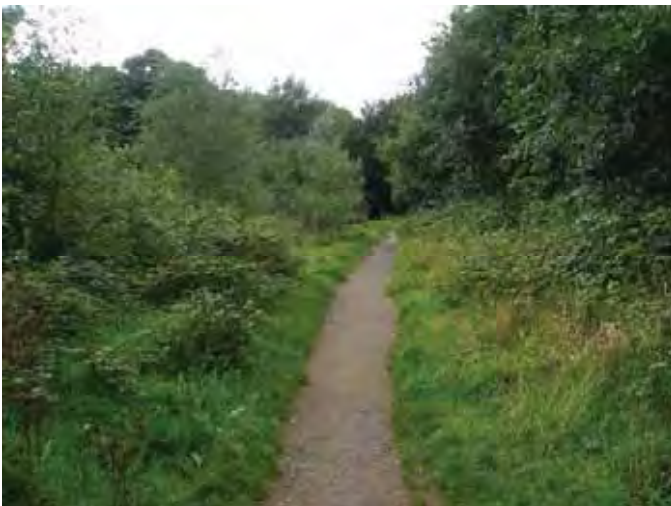
44: Path at foot of Church Bank visually enclosed

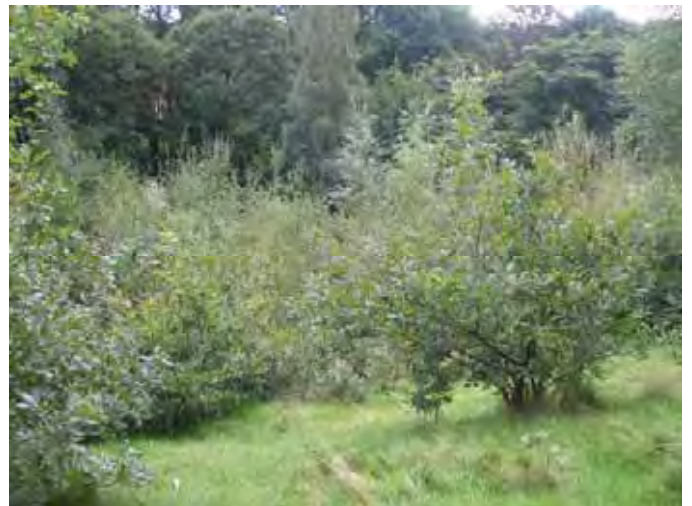
45: Tree regeneration / planting in a former open area

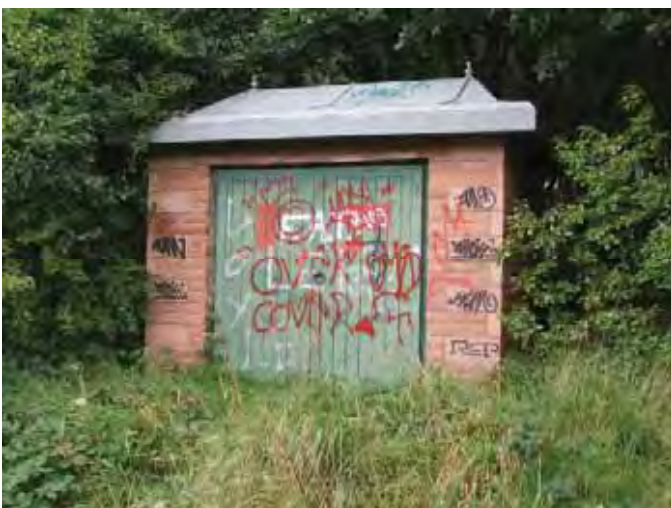
46: New service building with recent graffiti

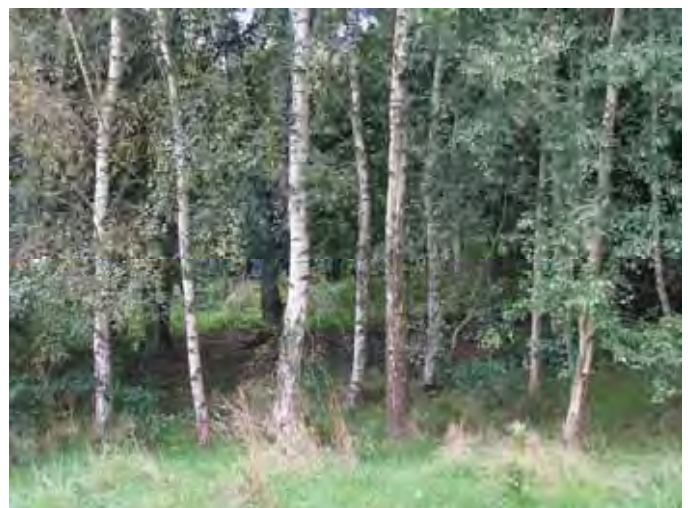
- 4.2.18 Views up Church Bank along this path are restricted by tree growth, which further down change from oak scrub to dense clumps of silver birch (**photo 47**).

47: Dense birch cover forms a barrier with Church Bank

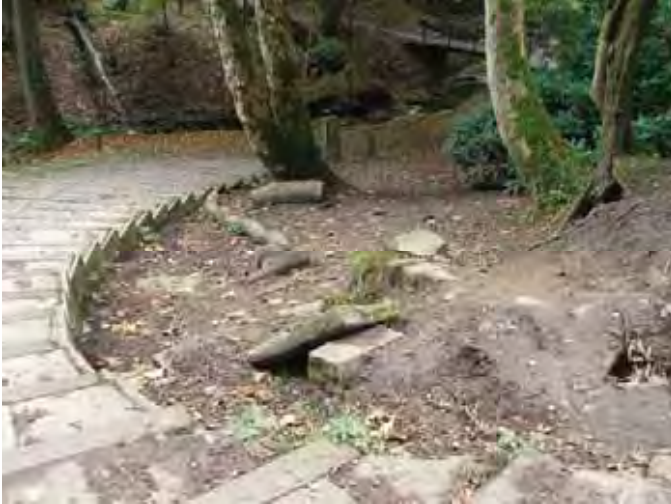
- 4.2.19 Within the existing Conservation Area there are three main entrances into Prestwich Clough, including the approach from St Mary's Park, the historic route down from the church and the 'formal' gateway on St Ann's Road. Below St Mary's Church a cobbled path leads to a major set of steps curving down to the main bridging point. Whilst the flight of steps, which are very wide, appear to be in reasonable condition, major erosion of the adjoining earth bank has taken place creating an unsightly and potentially dangerous approach down to the bridge (**photo sheet 8 / 48**).

48: Erosion of steps leading down to the main footbridge

Improve the appearance of the main bridging point by upgrading the bridge, restoring the steps, clearing the stream and selective tree removal to allow more light into the area.

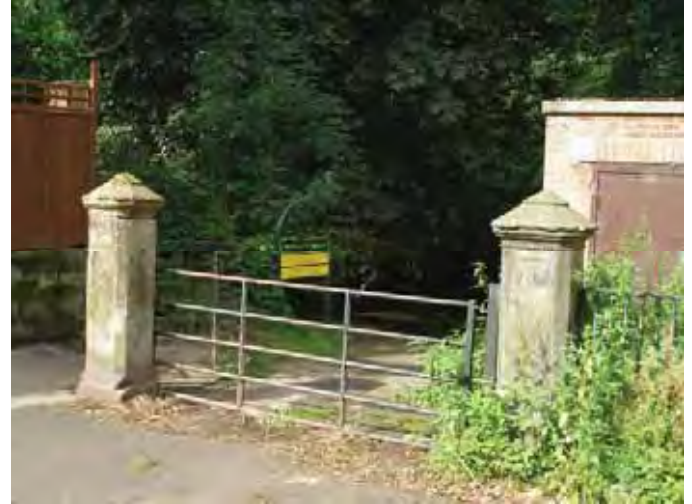
- 4.2.20 The other main entrance into the Clough is off St Ann's Road and consists of an original set of stone gate pillars with 'Prestwich UDC 1906' carved into the front face (**photo 49**). However, this original entrance is compromised greatly by a plethora of design styles and the dominance of the unsightly electricity sub-station. The path down into the Clough is reasonable but the bridging point is shady and the disrepair of the masonry walls that retain the stream bank makes for a dispiriting experience (**photo 50**). The entrance from St Mary's Park has already been described.

49: Poor entrance to the Clough from St Ann's Road

Improve the historic entrance to Prestwich Clough.

The landscape character of this area is largely derived from its population of street trees consisting of sycamore, beech or lime. It is important that this character is perpetuated and so a replacement policy should be adopted where appropriate. It should be noted, however, that in some instances it might be prudent to wait until two consecutive trees have failed before replacements are made as light is an important factor in a tree's growth and lack of it can induce poor vigour. However, this strategy will need to be assessed on a case by case basis. The experience of entering the Clough from St Anns Road is very poor and needs an improved design.

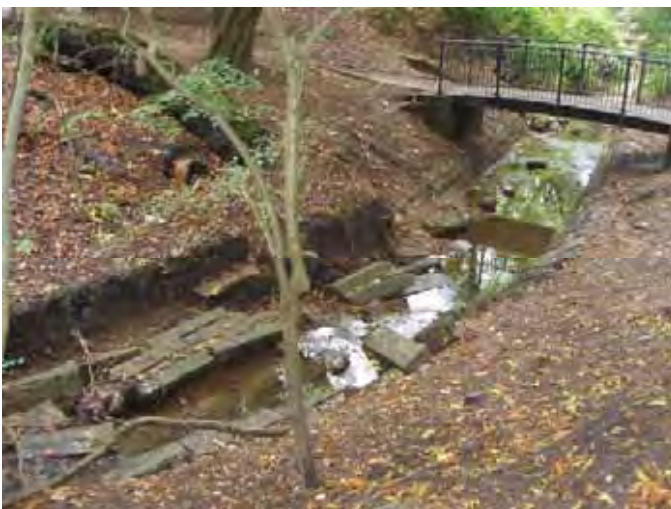
50: Dense canopy shade and fallen masonry not inviting

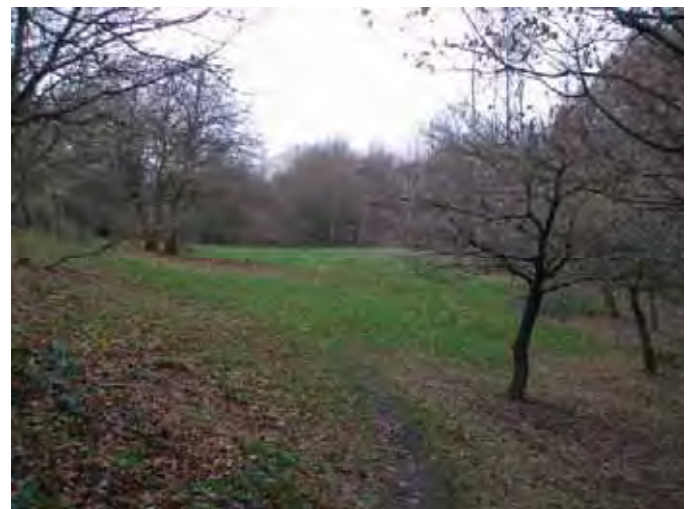
51: One of several open glades at the top of the Clough slope

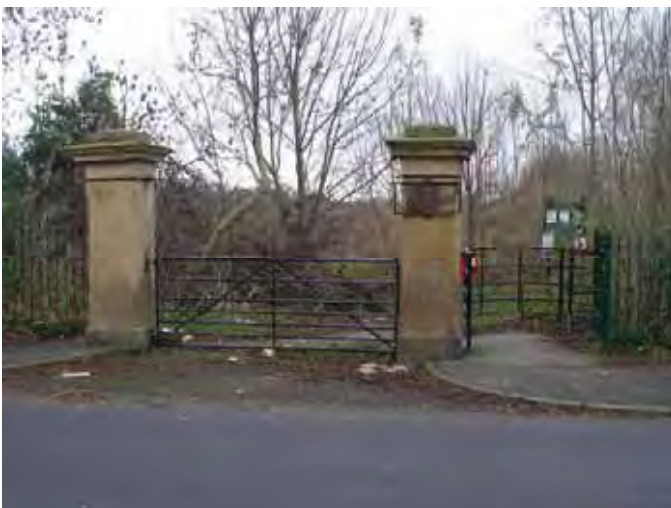
52: Entrance to Gardener's Mount in poor condition

Improve the historic entrance to Gardner Mount.

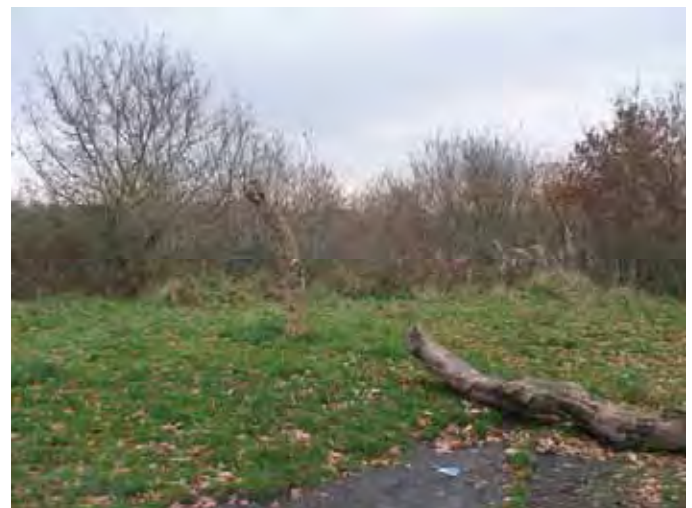
53: Former War Memorial site now enclosed by scrub
