Mount Pleasant Nangreaves

Conservation Area Appraisal and Action Plan

Metropolitan Borough of Bury
Creating a Brighter Borough

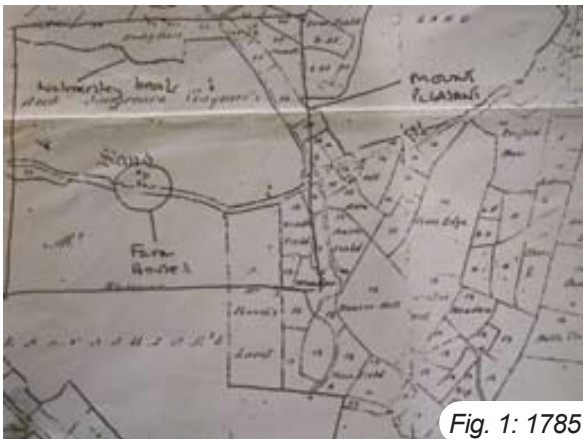
Fig. 1: 1785

The current village site was originally an area of pasture (fig 1) surrounding a farm. The buildings that still remain from the farm suggest that it may have been of local prominence. The land now included in the conservation area was purchased from Captain Richard Nangreaves by John Hall in 1819. John Hall's intention was to expand his textile business which had been initially set up at Gorsey Brow in 1803. An estate map of 1785 (fig 1) indicates farm buildings on the current site of Mount Pleasant, some of which were later used as a residence for John Hall whilst his new mill was under construction.

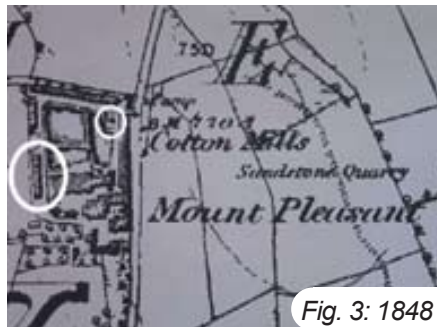
Fig. 3: 1848

The Ordnance Survey Map of 1848 (fig 3) shows the addition of a group of buildings (possibly dwellings) to the south west corner of the site and the north east lodge has been filled in and redeveloped.

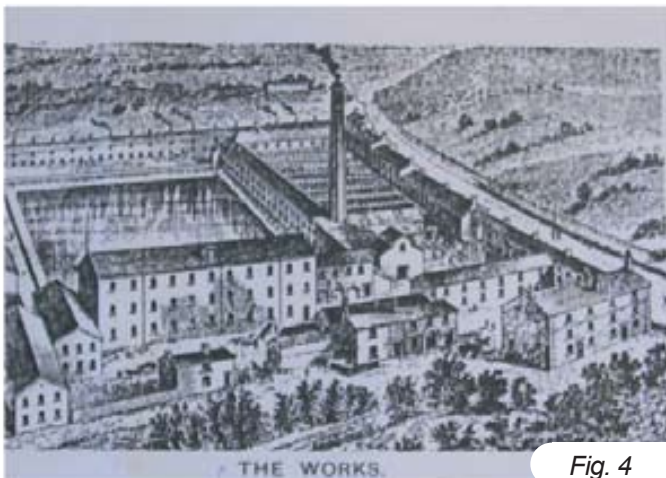
Fig. 4

The drawing of the village (fig 4) produced some time between 1893 and 1910 indicates how Mount Pleasant may have looked from the south with the weaving sheds, a large 3 storey block and mill entrance clearly visible.

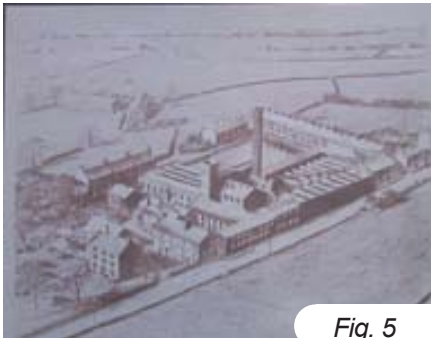
Fig. 5

The rare aerial photograph (fig 5) taken after 1903 shows the original farm house to the south. The farm house was demolished in the first half of the 20th century. This is probably the earliest photograph which shows the whole of what became the conservation area, including the terraces to the west.

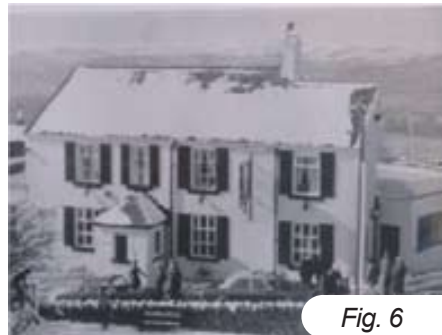
Fig. 6

The Lord Raglan public house (fig 6) is also a late 19th century development and a new addition to the 1893 map. Its name commemorates the involvement of Lord Raglan in the charge of the light brigade during the Crimea War and provides us with further insight into the cares and concerns of this local community in the late 19th century.

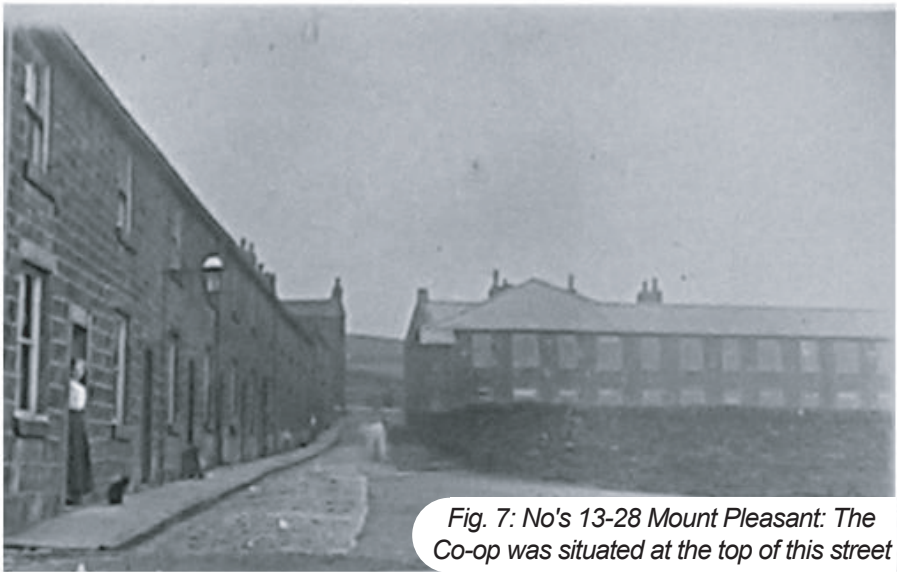
Fig. 7: No's 13-28 Mount Pleasant: The Co-op was situated at the top of this street

During the first half of the 20th century the village had a co-operative grocery (fig 7) and provisions store and a chapel. On the east side of the village across the main road were a set of outside toilets. Curiously, one of the entrances to the site was adorned with a set of whalebones arched over the entrance.

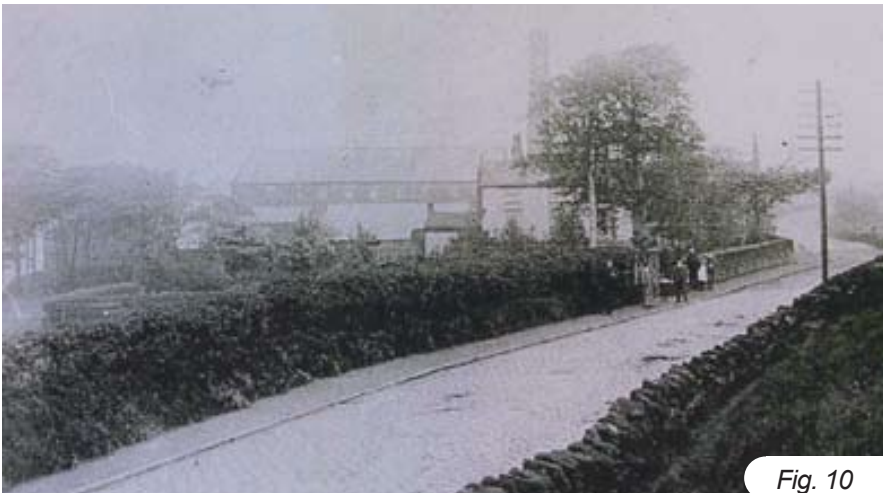
Fig. 10

The current bus terminus sits upon the location of the original farm house site noted in the estate map of 1785. A photograph (fig 10) taken from the south at the turn of the 20th century shows a domestic residence, which corresponds with the cluster of farm buildings furthest south on the maps.

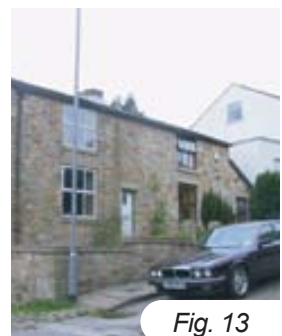
Fig. 13

A study of the buildings illustrates the area's agricultural and industrial origins. All buildings are simple and functional in form and detail. They are predominantly two storey and are constructed from locally quarried millstone grit and sandstone and once had sandstone covered roofs (fig 13).

Stone flag and slate roofs should be retained and repaired. Every effort should be made to keep the remaining examples of stone roofs. The sealing over of existing roofs is not appropriate. Many terraces have traditional ridge tiles and stone copings/cement fillets to the verges. These should be retained, and verges should not be replaced with barge boards, either upvc or timber. Also, be aware of imported stone and slate. This may be offered at a lower price but may not be a convincing substitute for the local natural material.

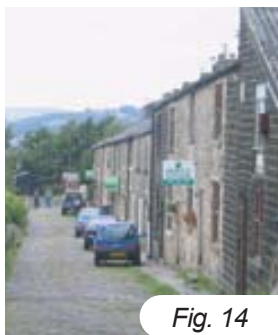
Fig. 14

Although the village was built in phases it was constructed to a standard pattern and followed rules of function and uniformity. Consequently, the buildings have regular shapes and groupings, sizes and proportions of openings, and common features and detail, all of which reflect its factory village origins (fig 14). During construction there was no attempt at elaboration or for fanciful design and colour. Carved stone work is hard to find and where it does exist it is also completely functional. Although the architecture is plain it has a colour, rhythm and quality that should not be lost. The area character reflects the people who during the 19th century built, worked and lived in Mount Pleasant, being straightforward, hardy and resolute. This was a key factor in creating the distinctiveness of the conservation area and one that should be uppermost in addressing the area's future.

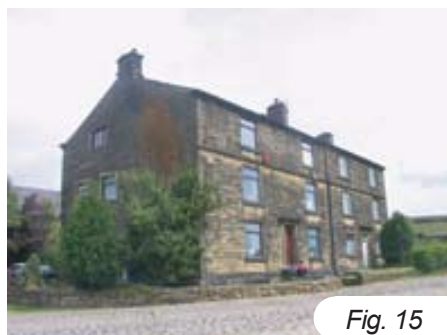
Fig. 15

Evidence also survives in the village of building structures which appear to be in existence before the industrial development. The listing description for the Mill House (fig 15) notes a set of chamfered stone mullioned windows which pre-date the industrial village. This type of window was prominent in the 17th and 18th centuries. Other early openings are also evident at the rear and on each gable. The mill house is a building of more substantial form than the later cottages, with a cellar, and first and second floors. It has been altered and

includes some modern windows but retains its character exhibiting a range of watershot coursed and rubble walls, a large stone plinth and string course and large stone quoins. The main body of the building is probably 18th century with 19th century re-fronting and alterations. This was almost certainly one of the farm buildings indicated on the estate map of 1785. Adjacent to the mill house, the mill yard cottage's stone front also reveals its 19th century use with the entrance arches for stables still visible (fig 16). This again is thought to be a re-fronting of an earlier building. Continuing along the theme, numbers 11 and 12 have chamfered stone mullioned windows in their cellars (fig 17). Are these due to the fashion for using older methods of construction in less prominent positions or are they also part of an earlier rebuilt property? Fig 2, page 6 may help, the properties do appear to be on an odd alignment. However, the square mullions that are still in place at the rear of numbers 8 and 10 (fig 18) are probably consistent with the beginning of the 19th century.

Generally, the main openings in walls should not be altered in size or shape or cills and lintels removed or adjusted. There are a number of early stone mullions in windows and these must not be removed or altered unless repair is essential.

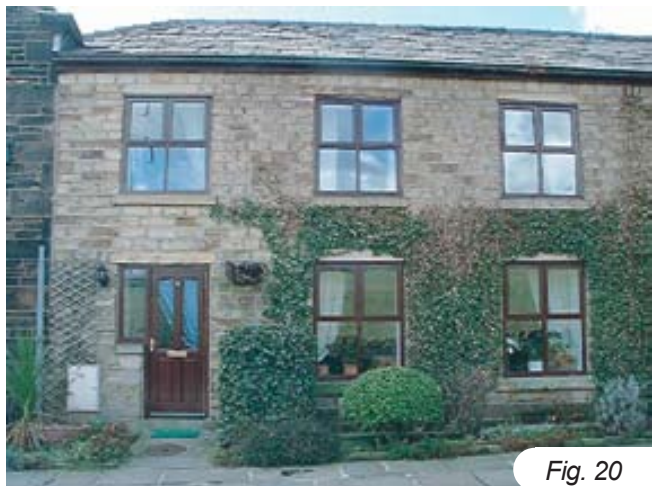
Fig. 20

Unfortunately, little remains of the original mill structure, with only the walls to the east and south being incorporated into the residential redevelopment (fig 20).

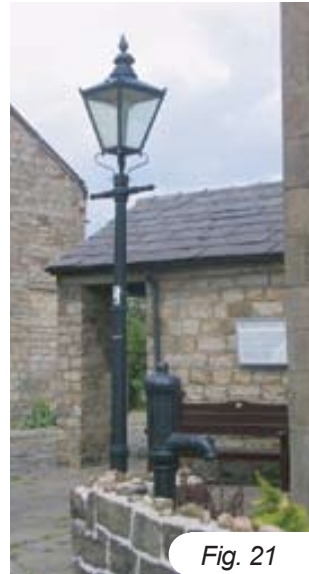
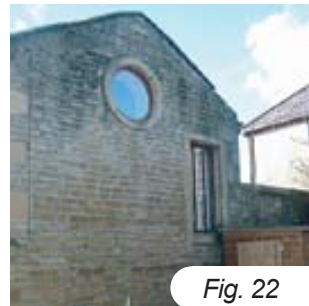
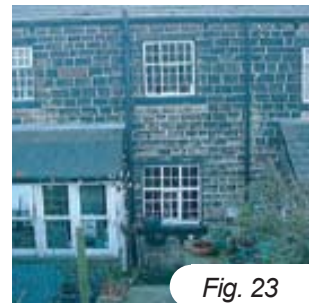
The list of particular details is extensive and are as important in Mount Pleasant as in any other area of special quality. Look around the detail of the area. Take note of what remains of the building skills and crafts of the past 200 years. Artefacts from the past also help to confirm the area's identity. Old lighting columns, ironwork, brackets, rainwater pipes etc can all make a difference (figs 21, 22 and 23).

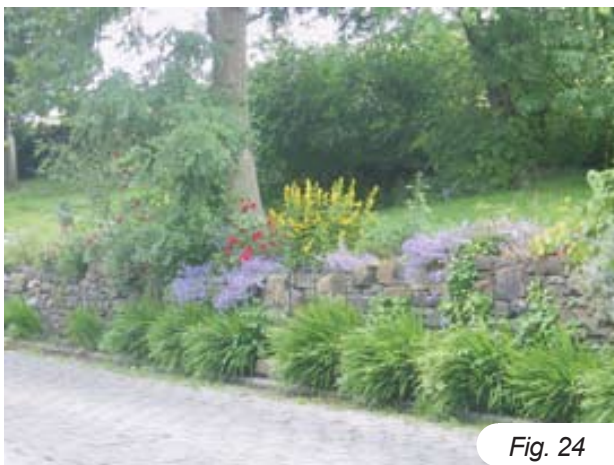
Fig. 24

At the largest scale, the existing conservation area boundary (see plan 1) largely remains relevant to early land ownerships. It skirts Walmersley Old Road to the east and incorporates a section of land to the east side of the road. This site once housed WC blocks but is now a pleasant garden area (fig 24). To the north west the boundary includes the grade II listed terraced houses numbers 13 to 28 and their garden plots, and stretches out to encompass the terraced houses and allotment plots to the west. Interestingly, the short boundary furthest east still follows the original boundary line of Captain Richard Nangreaves estate shown in the map of 1785. Moving south the boundary includes a triangular 'peninsula' of land incorporating an area of shrubs and trees. This was originally the cultivated garden of the farmhouse once occupied and probably improved by John Hall with its strong stone boundary to Walmersley Old Road.

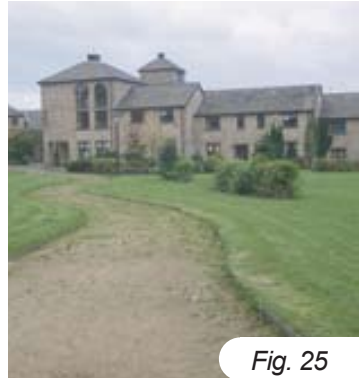
Fig. 25

Within the village the modern properties built from the reused stone of the weaving sheds follow broadly the original factory footprint (fig 25). The village green also follows the boundary of the last surviving lodge to have existed at Mount Pleasant. These are all reminders of the area's history and growth.

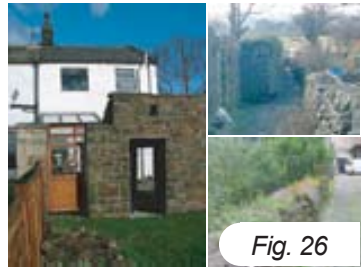
Fig. 26

There are a variety of stone walls (fig 26) which provide both enclosure and common features appropriate to the village setting. They remain generally intact and are a key landscape feature, in some cases providing a line of continuity from the pre-industrial development of the village.

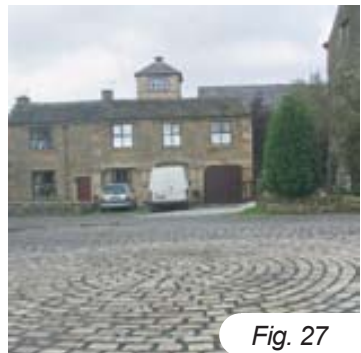
Fig. 27

The roads, which skirt and penetrate the village, are themselves distinctive features that contribute to the overall character of the conservation area. The extent of the surviving and new stone setts tie together the various elements of the village, even integrating such features as the bus turnaround (fig 27). The consistent form, colour and texture of the flagstone setts creates a visual harmony between existing stone paving, kerbs walls and roofs.

- The repair and enhancement of the sett roadway within the village and its possible extension to cover small areas of unmade roadway where appropriate.
- The provision of additional car parking areas for rent for both the upper and lower areas of the village.
- The upgrading of street lighting within the area following an appropriate heritage design.
- Investigation of a communal aerial for the village.
- Works for woodland management to ensure good practice and to secure and protect views into and out of the village.
- The provision of a new village sign, to be consistent with a conservation area pattern yet to be designed.

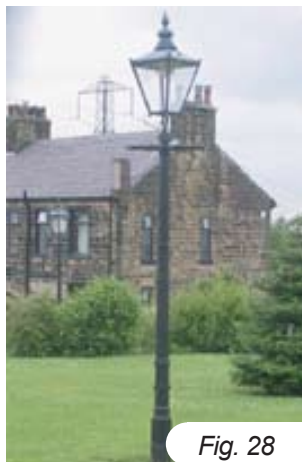
Fig. 28

Two key open spaces exist within the conservation area. The privately managed, semi-formal village green on the site of the former lodge is enclosed by the core building group and provides a focal point of high amenity value (fig 28). To the south of the green the old steam engine base plinths have been incorporated into the landscape as a reminder of the area's origins. The village green therefore provides a link with the past and also helps to bring the new houses and flats into a cohesive village core.

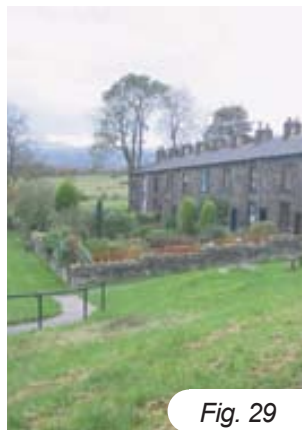
Fig. 29

The terraces further to the west (fig 29) are fronted by gardens constructed in the 1980s and the, Council managed, open field. This area is used for community activities throughout the year and is enclosed by a group of mature trees, which give an important backdrop for the open space, and possibly helps to mute the sound of traffic from the motorway further to the east. Access to the lower terraces is by a series of flagstone steps. To the side of the steps is a small stream which is channelled across the front of the terraces (numbers 41-50).

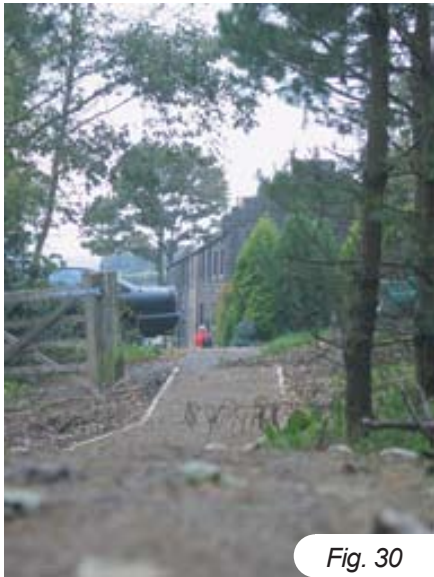
Fig. 30

The main building group with its central green, and the terraces to the west, are linked by a road and footpath (fig 30). The footpath cuts through a plantation of mature trees which provide a break between the two parts of the settlement, and creates an attractive green space and wildlife habitat. It also links to the wooded and garden areas to the south of the village. This important area is now within the conservation area and is a strong feature in the character of the village.

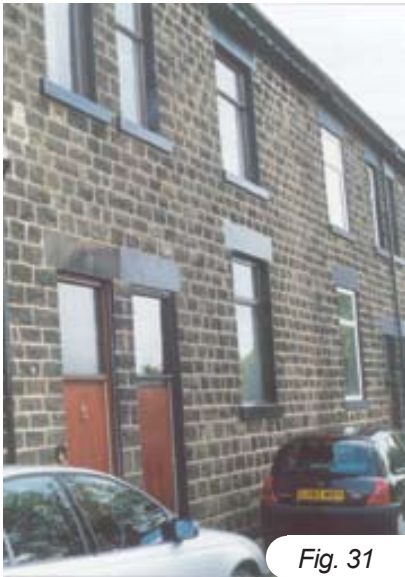
Fig. 31

Modern life has changed the setting of the village. Car parking continues to be an issue. Both cars and garages have had an impact on the area's character and intrude into its daily life (fig 31). Some improvements have been made but the situation requires further attention.

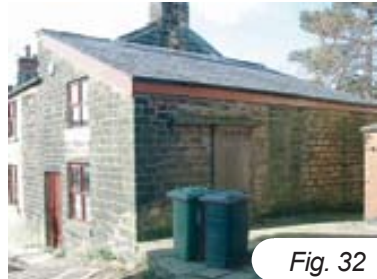
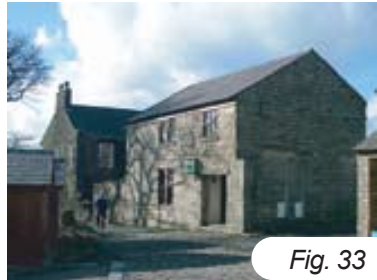
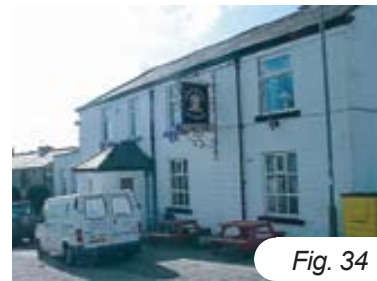
In Mount Pleasant the erosion of traditional character has centred primarily upon changes to window details and doors, followed closely by a range of new elements such as satellite dishes, aerials, flues, alarms, changes to roof materials and chimneys, the painting of stone walls, and the construction of conservatories, porches, canopies, garden boundaries and a range of garages and sheds (figs 32, 33 & 34).
